CT Hydraulics (Nqoba) (Pty) Ltd

Company	Description	Part Number	Customer Ref. No.
	Titan "A" Drill Feed Cylinder

Report done by	Date	CT Job Number
	2026-02-16

Warranty Claim	Normal Repair
	X

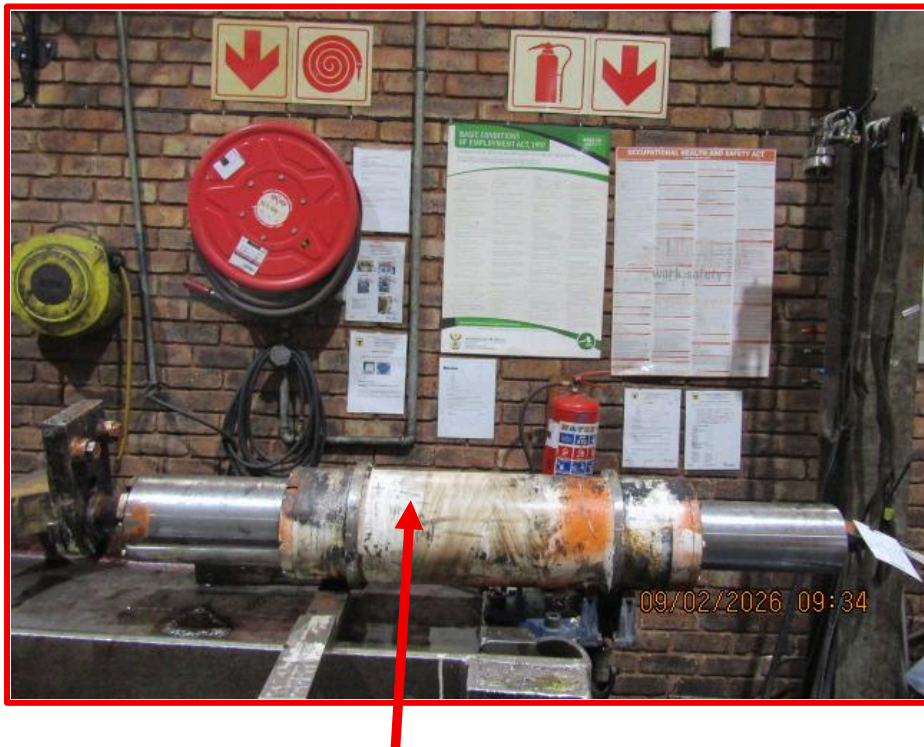
Cylinder on arrival.

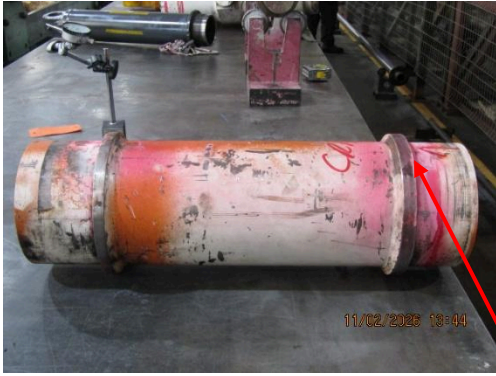
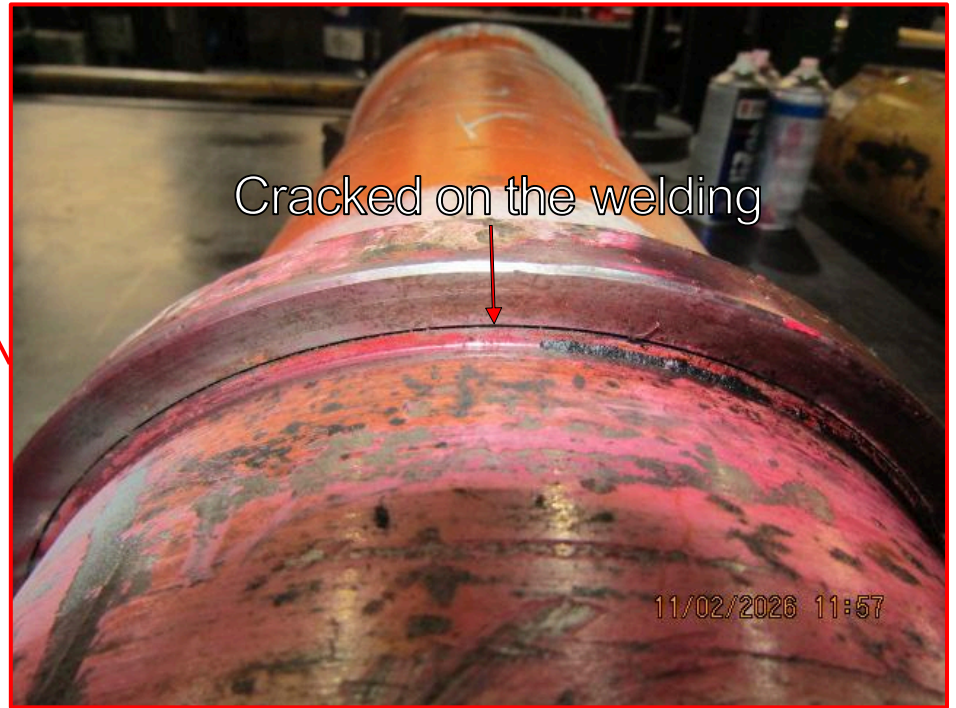
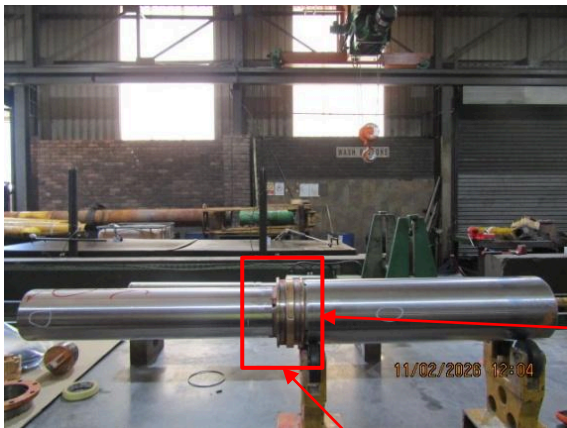
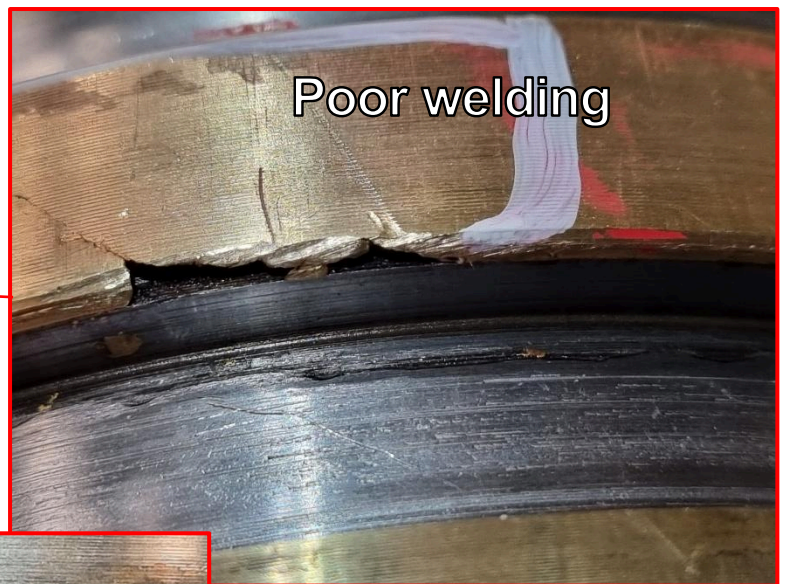
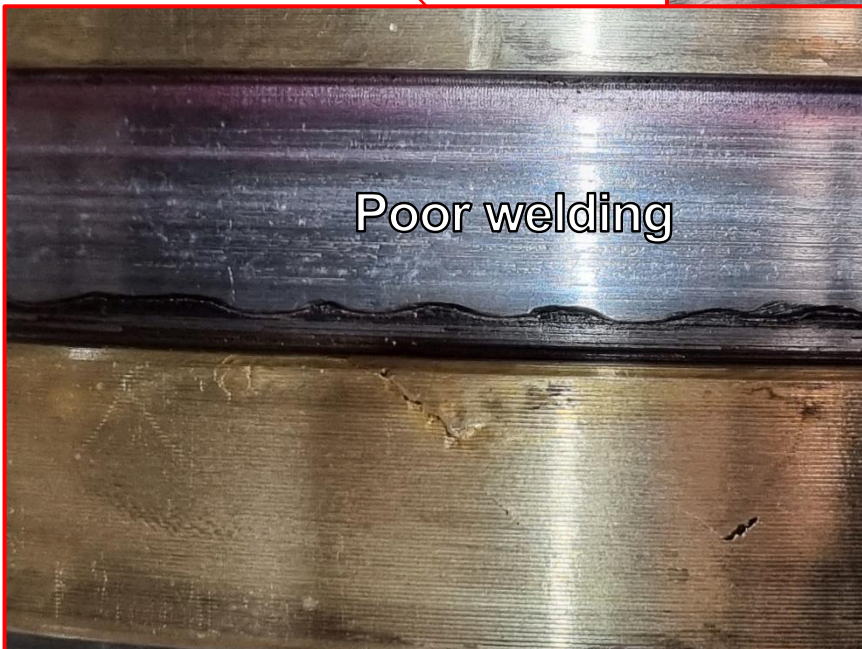
Photos of component after dismantling:

Based on inspection, cracks were found on the barrel welding and 1st stage piston shows signs of poor welding.

The damage noted on these components was potentially due to one or a combination of the following:

➤ **Non-compliance with welding procedures.**

Incorrect or inconsistent welding parameters used.

➤ **Inadequate weld preparation and joint profiling.**

Improper weld groove profile likely resulted in weak fusion and poor bead geometry.

These welding defects should have been detected during inspection.
