CT Hydraulics (Nqoba) (Pty) Ltd

Company	Description	Part Number	Customer Ref. No.
	Boom Swing Cylinder

Warranty Claim	Normal Repair
	X

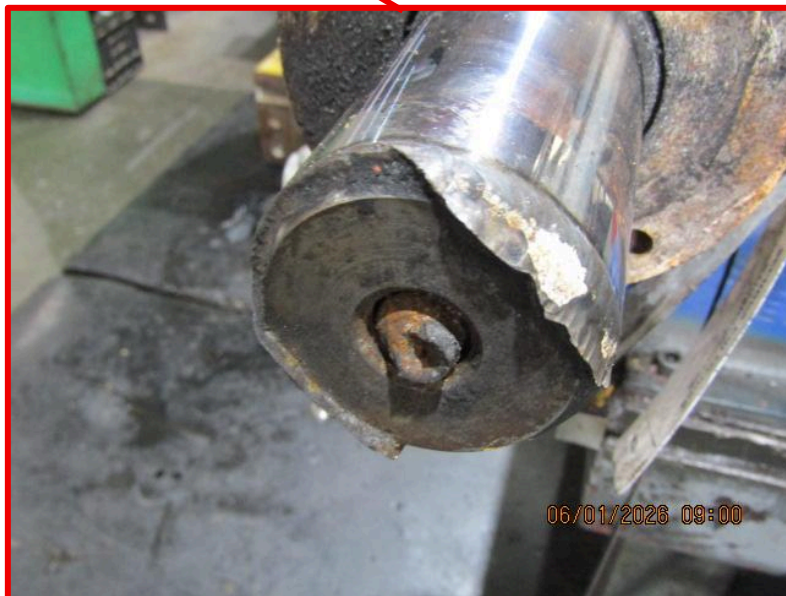
Photos of component on arrival:

Rod clevis broke off.

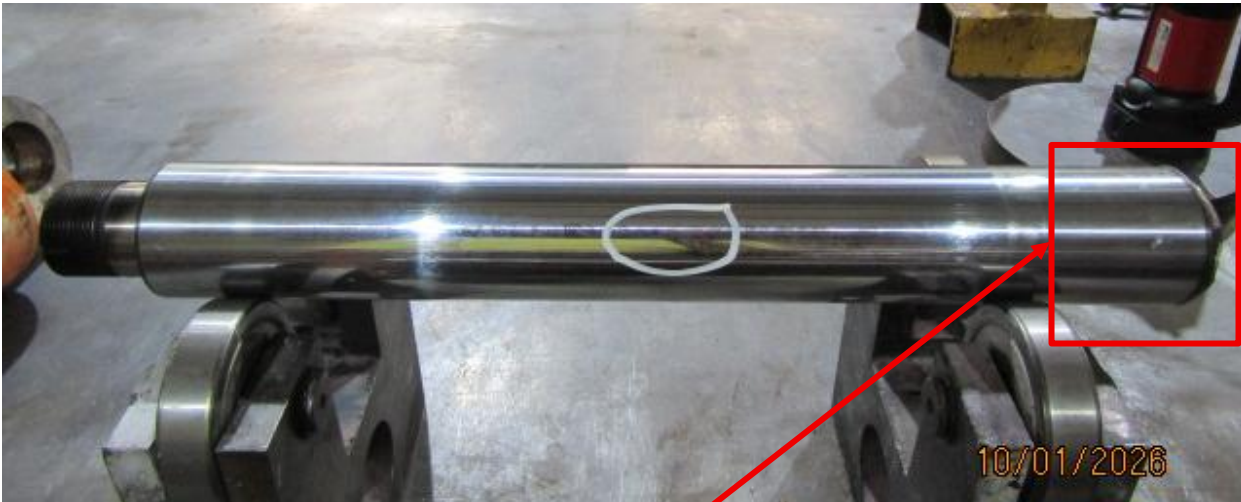
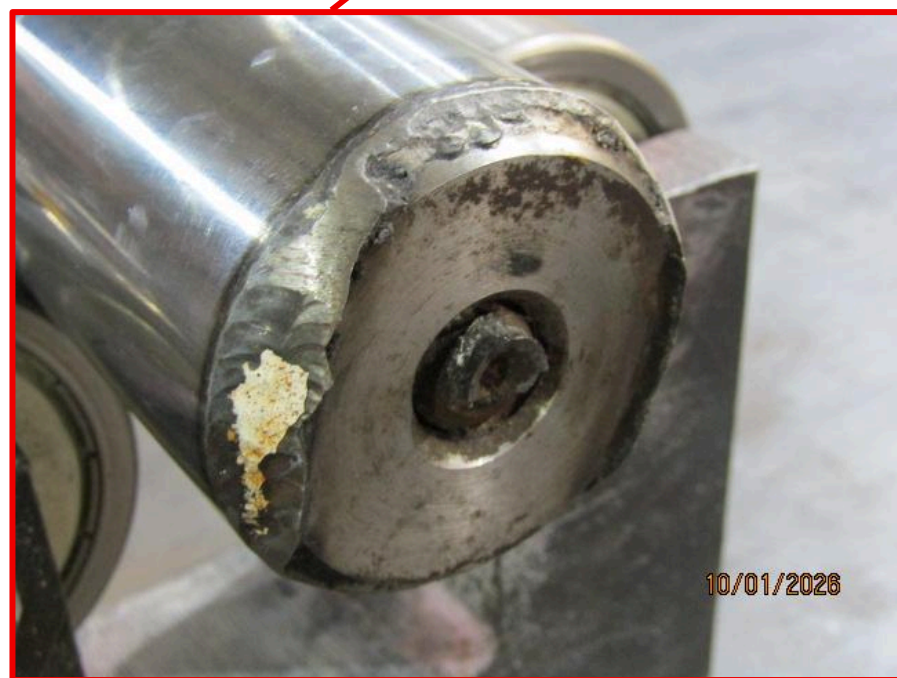
Photos of component after dismantling:

The piston rod shows signs of poor welding profile.

Based on inspection, the following was noted:

- Poor welding profile between the piston rod and the rod clevis led to structural weakness.
- The failure occurred due to inadequate welding standards during prior repair, not original manufacturing defect.
